SCOPRIO SC DC CRDe LHD

SERVICE MANUAL

**TECHNICAL PUBLICATION CELL
MAHINDRA & MAHINDRA LTD**

VERSION 0 – JULY 2006

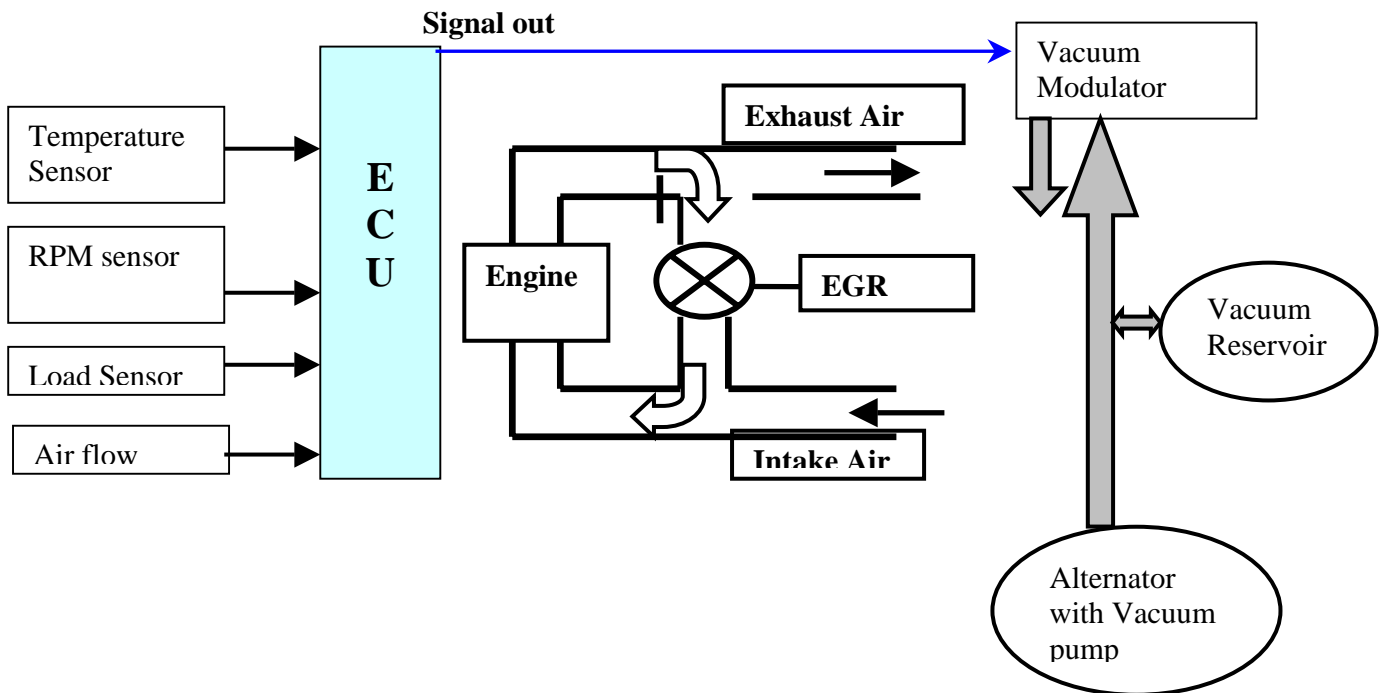
Working Principle of the Exhaust Gas Recirculation

During acceleration and in higher loads the combustion chamber temperatures increase. The high combustion temperatures increase the NO_x generation. The higher percentage of NO_x generated in the combustion chamber come out through the tail pipe in the atmosphere.

To reduce the amount of NO_x coming through the tail pipe the EGR system adds exhaust gases into the fresh air that is going into the combustion chamber. Since the exhaust gas is already burnt hence when mixed with fresh air acts an inert gas. Thus when the exhaust gas mixed with fresh air enters the combustion chamber, it performs a dual role. The first role it does is that it reduces the amount of oxygen available for combustion. The second role that it acts is as a heat absorbent/heat sink.
